**Flood Control Project Maintenance  
Levee Inspections**

**Fall 2013 Levee Maintenance Deficiency Summary Report**

**San Joaquin River Basin**

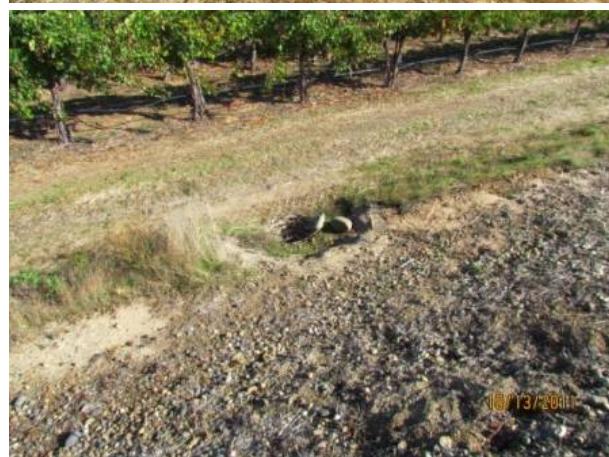
Levee Mile Report Line	88
Start Levee Mile	15.77
End Levee Mile	15.77
Location	Land Side
Category	Earthen Levee
Item	Encroachments
A drain was found at the toe of landside of the levee. The picture was taken from the crown looking towards the toe.	
pkazi_f_20131001_079.jpg

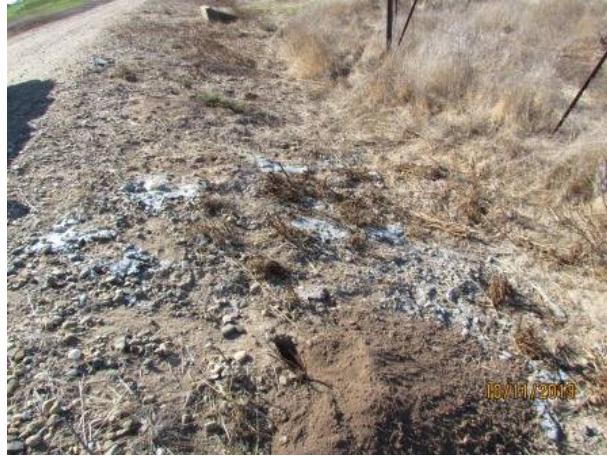
Levee Mile Report Line	89
Start Levee Mile	15.87
End Levee Mile	15.87
Location	Land Side
Category	Earthen Levee
Item	Animal Control
Animal holes were found on the landside of the levee looking downstream.	
pkazi_f_20131019_959.JPG

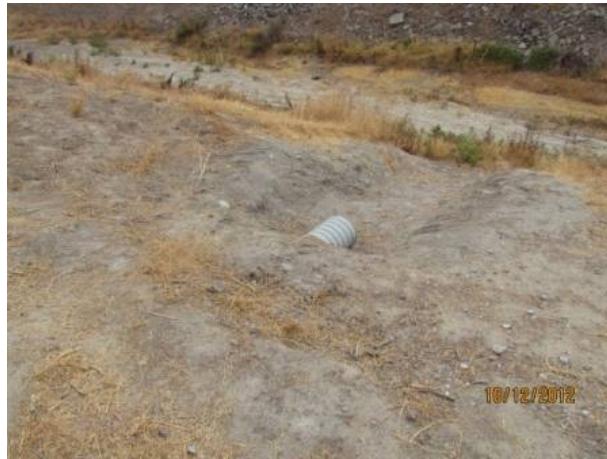
Levee Mile Report Line	90
Start Levee Mile	16.07
End Levee Mile	16.07
Location	Land Side
Category	Earthen Levee
Item	Encroachments
A pipe was found on the waterside slope of the levee looking upstream.	
pkazi_f_20131001_072.jpg

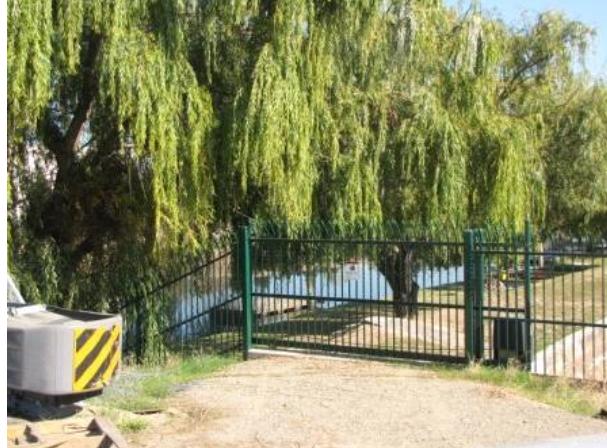
Levee Mile Report Line	1
Start Levee Mile	0.78
End Levee Mile	0.78
Location	Crown
Category	Earthen Levee
Item	Encroachments
View of a open fence and gate across the crown at the current start of the unit looking upstream. Limited access has been provided.	
pkazi_f_20131001_163.jpg

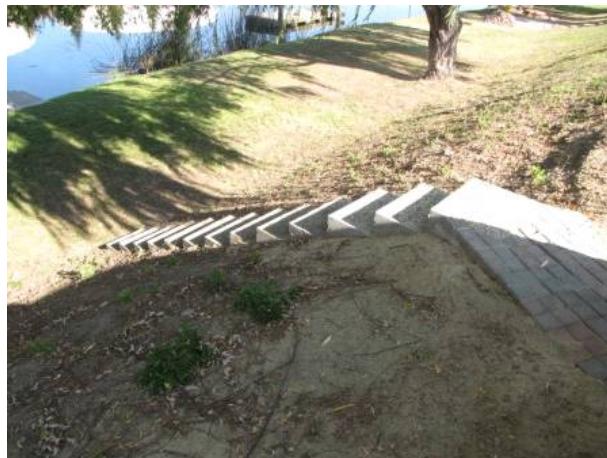
Levee Mile Report Line	2
Start Levee Mile	0.78
End Levee Mile	0.78
Location	Water Side
Category	Earthen Levee
Item	Encroachments
View of steps on the waterward slope of the levee looking upstream.	
pkazi_f_20131001_164.jpg

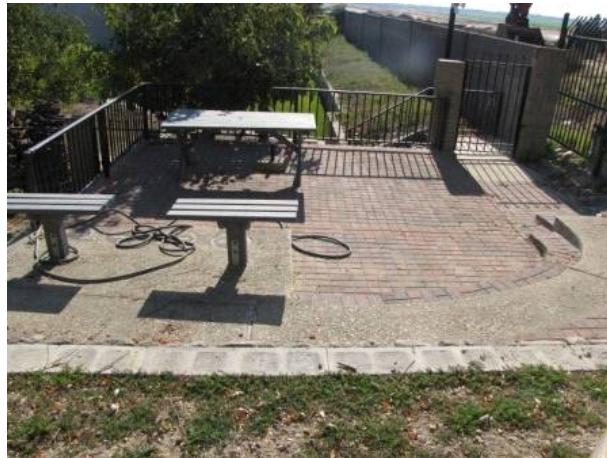
Levee Mile Report Line	3
Start Levee Mile	0.78
End Levee Mile	0.79
Location	Land Side
Category	Earthen Levee
Item	Encroachments
View of a patio with table, benches, and irrigation on the landward side of the levee.	
pkazi_f_20131001_165.jpg

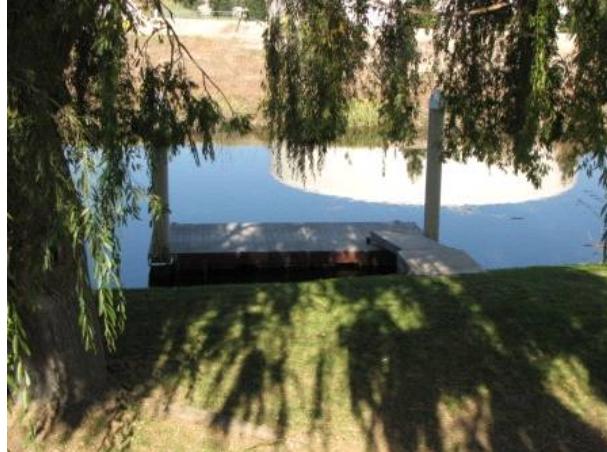
Levee Mile Report Line	4
Start Levee Mile	0.79
End Levee Mile	0.79
Location	Water Side
Category	Earthen Levee
Item	Encroachments
View of a dock off the waterward berm.	
<i>pkazi_f_20131001_166.jpg</i>

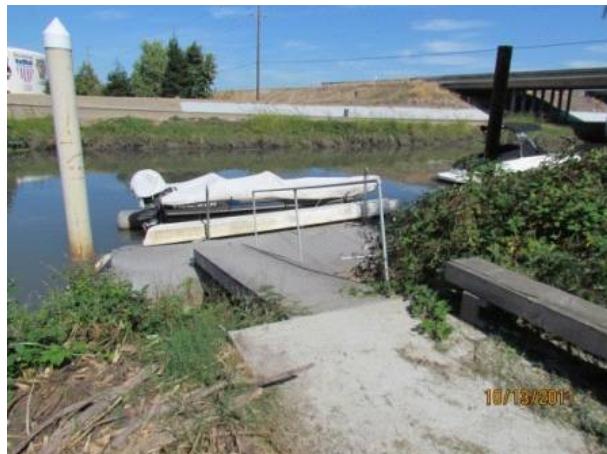
Levee Mile Report Line	4
Start Levee Mile	0.79
End Levee Mile	0.79
Location	Water Side
Category	Earthen Levee
Item	Encroachments
View of the dock at the waterside of the levee during fall 2011 inspection. The picture was taken from the crown looking upstream.	
<i>pkazi_f_20131001_167.jpg</i>

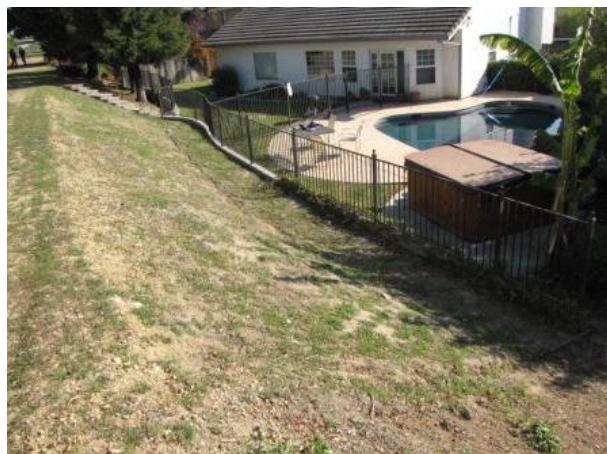
Levee Mile Report Line	5
Start Levee Mile	0.79
End Levee Mile	0.81
Location	Land Side
Category	Earthen Levee
Item	Encroachments
View of a fence on top of a retaining wall in the landward toe of the levee. Some landscaping and irrigation are also present.	
<i>pkazi_f_20131001_168.jpg</i>

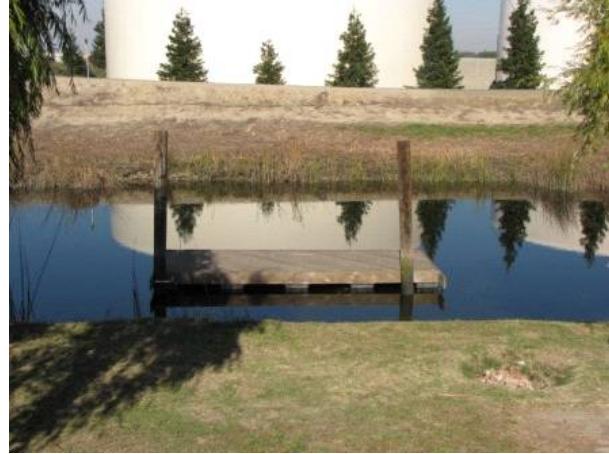
pkazi\_f\_20131001\_169.jpg

View of a dock off the waterward side of the berm.

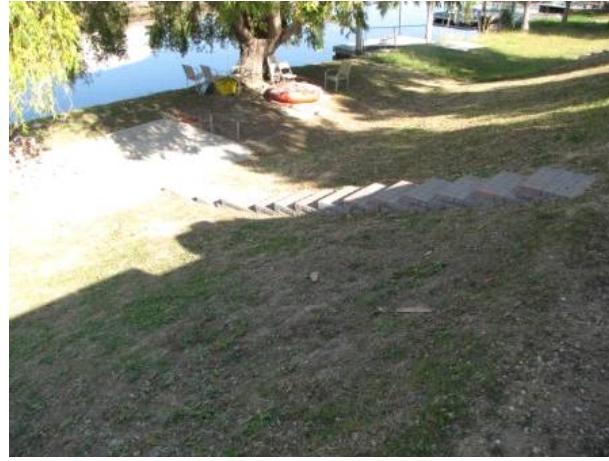
pkazi\_f\_20131001\_170.jpg

Levee Mile Report Line	7
Start Levee Mile	0.80
End Levee Mile	0.80
Location	Water Side
Category	Earthen Levee
Item	Encroachments

View of stairs and patio on the waterward slope and berm looking upstream.

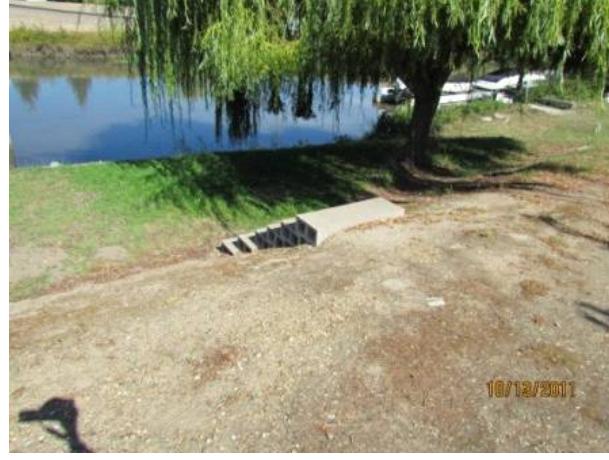
pkazi\_f\_20131001\_171.jpg

Levee Mile Report Line	7
Start Levee Mile	0.80
End Levee Mile	0.80
Location	Water Side
Category	Earthen Levee
Item	Encroachments

Stairway on the waterside slope of the levee during fall 2011 inspection.

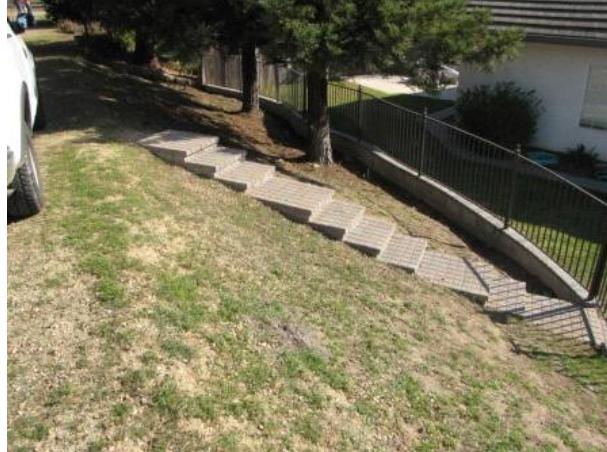
Levee Mile Report Line	8
Start Levee Mile	0.80
End Levee Mile	0.80
Location	Land Side
Category	Earthen Levee
Item	Encroachments
View of steps on the landward slope looking upstream.	
<a href="#">pkazi_f_20131001_180.jpg</a>

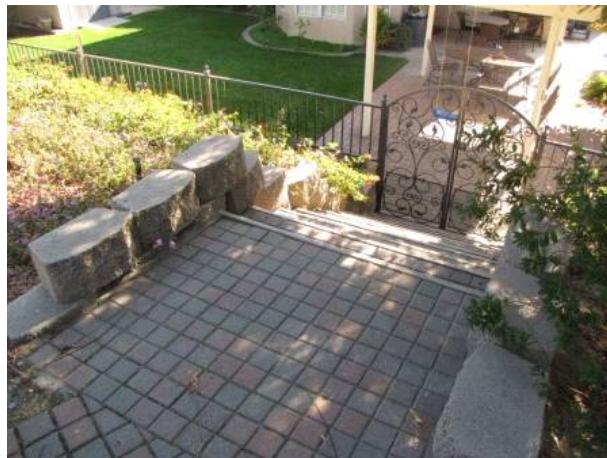
Levee Mile Report Line	9
Start Levee Mile	0.81
End Levee Mile	0.81
Location	Land Side
Category	Earthen Levee
Item	Encroachments
View of steps on the landward slope.	
<a href="#">pkazi_f_20131001_174.jpg</a>

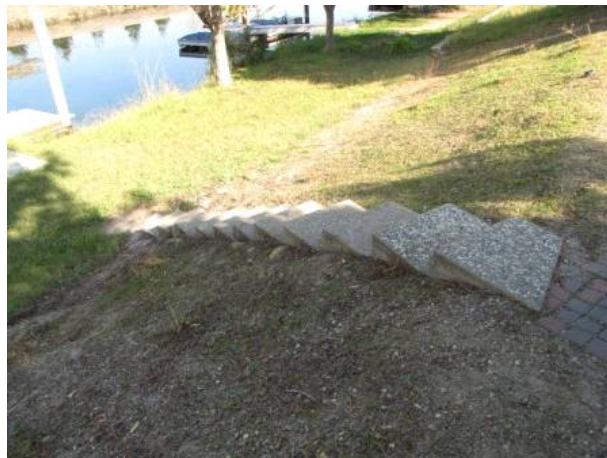
Levee Mile Report Line	10
Start Levee Mile	0.81
End Levee Mile	0.81
Location	Water Side
Category	Earthen Levee
Item	Encroachments
View of steps on the waterward slope looking upstream.	
<a href="#">pkazi_f_20131001_175.jpg</a>

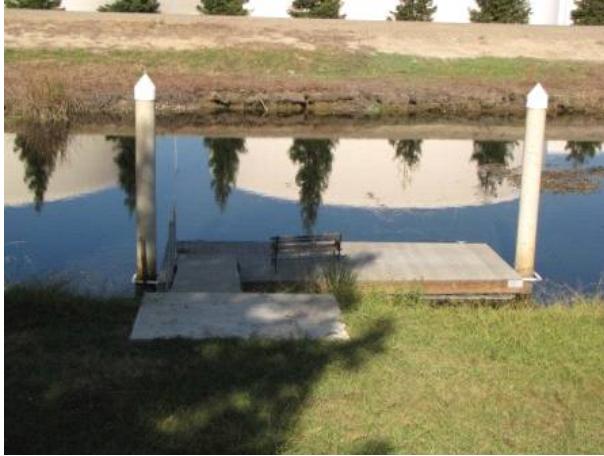
pkazi\_f\_20131001\_176.jpg

View of a dock on the waterward side of the berm.

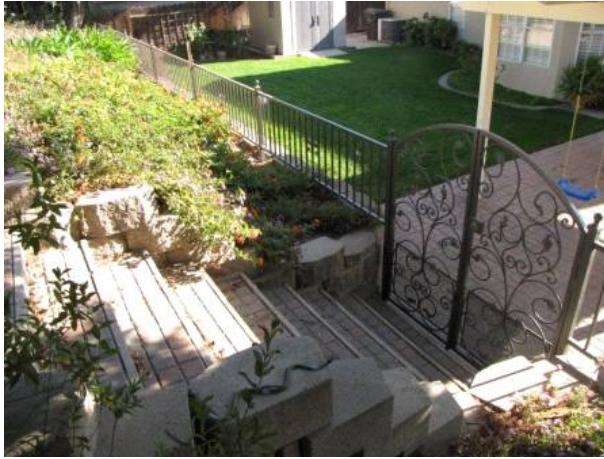
pkazi\_f\_20131001\_172.jpg

Levee Mile Report Line	12
Start Levee Mile	0.81
End Levee Mile	0.82
Location	Land Side
Category	Earthen Levee
Item	Encroachments

View of a open fence on a retaining wall in the landward toe of the levee looking upstream.

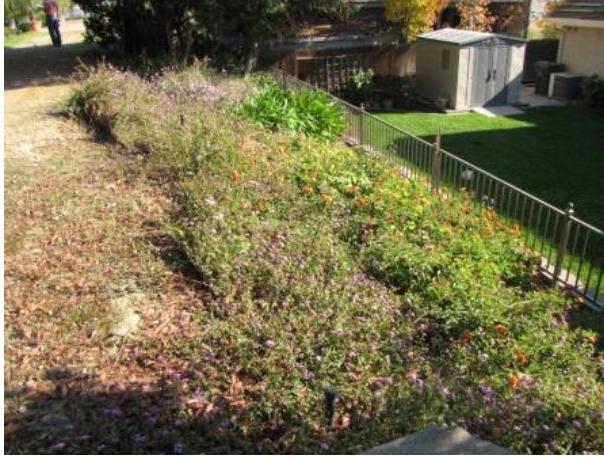
pkazi\_f\_20131001\_173.jpg

Levee Mile Report Line	13
Start Levee Mile	0.81
End Levee Mile	0.82
Location	Land Side
Category	Earthen Levee
Item	Vegetation

View of landscaping obstructing visibility and access and irrigation along the landward slope looking upstream.

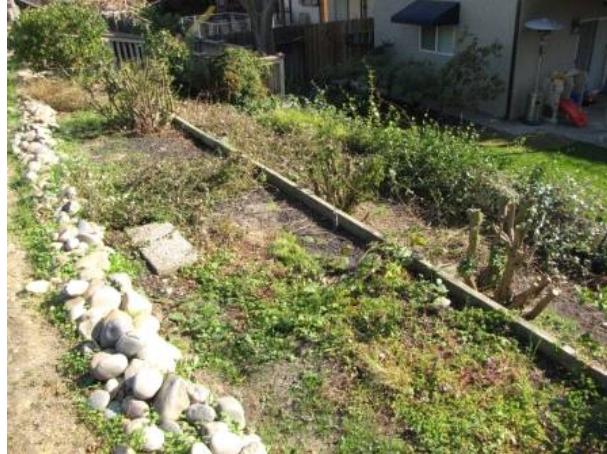
Levee Mile Report Line	15
Start Levee Mile	0.82
End Levee Mile	0.83
Location	Land Side
Category	Earthen Levee
Item	Vegetation
View of landscaping and irrigation along the landward slope looking upstream.	
<i>pkazi_f_20131001_177.jpg</i>

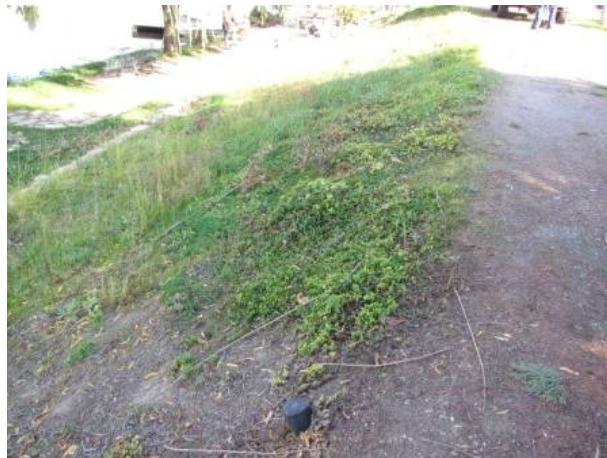
Levee Mile Report Line	16
Start Levee Mile	0.82
End Levee Mile	0.83
Location	Water Side
Category	Earthen Levee
Item	Vegetation
View of landscaping and irrigation on the waterward slope looking upstream.	
<i>pkazi_f_20131001_178.jpg</i>

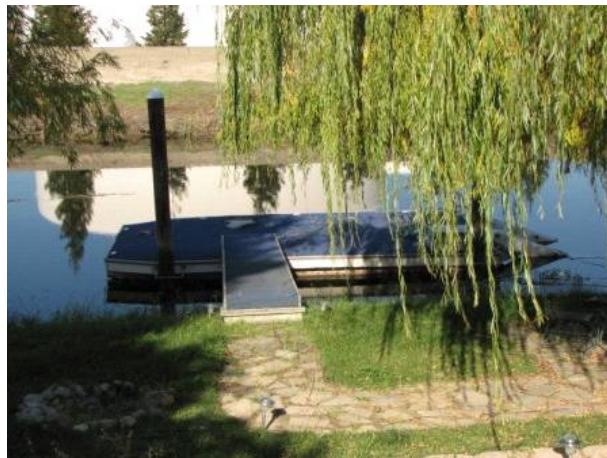
Levee Mile Report Line	17
Start Levee Mile	0.82
End Levee Mile	0.82
Location	Water Side
Category	Earthen Levee
Item	Encroachments
View of a dock and pathway on the waterward side of the berm.	
<i>pkazi_f_20131001_179.jpg</i>

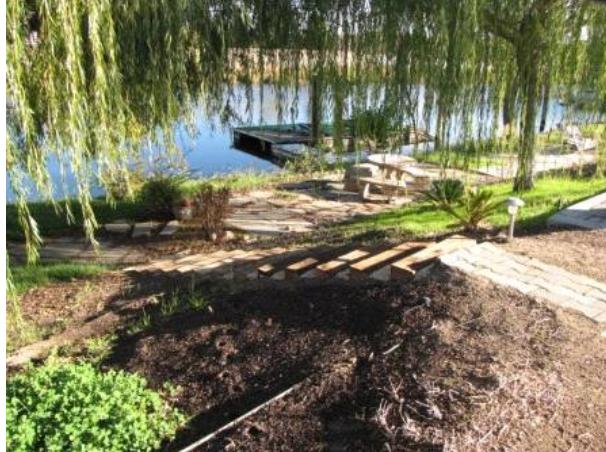
Levee Mile Report Line	18
Start Levee Mile	0.83
End Levee Mile	0.83
Location	Land Side
Category	Earthen Levee
Item	Encroachments
View of recently modified steps on the waterward slope of the levee looking upstream.	
<i>pkazi_f_20131001_086.jpg</i>

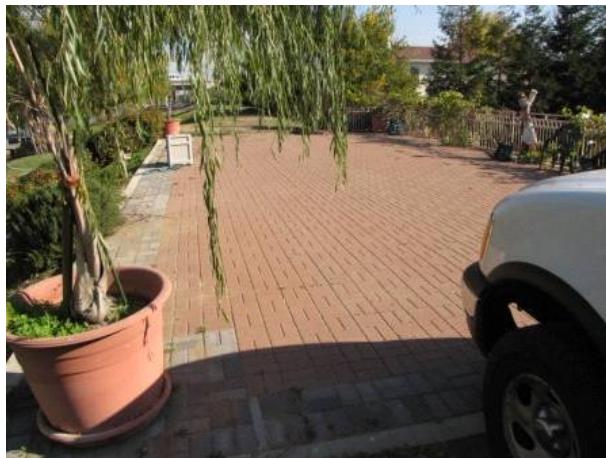
Levee Mile Report Line	19
Start Levee Mile	0.83
End Levee Mile	0.84
Location	Crown
Category	Earthen Levee
Item	Encroachments
View of pavers placed on the crown of the levee looking upstream. Potted landscaping and irrigation can also be seen.	
<i>pkazi_f_20131001_181.jpg</i>

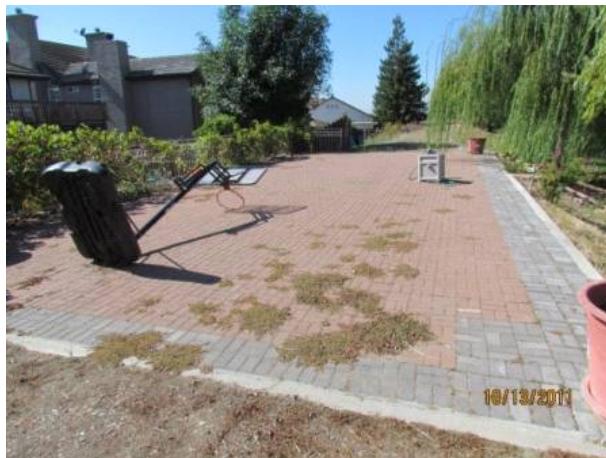
Levee Mile Report Line	19
Start Levee Mile	0.83
End Levee Mile	0.84
Location	Crown
Category	Earthen Levee
Item	Encroachments
View of pavers placed on the crown looking downstream. This picture was taken during fall 2011 inspection.	
<i>pkazi_f_20131001_182.jpg</i>

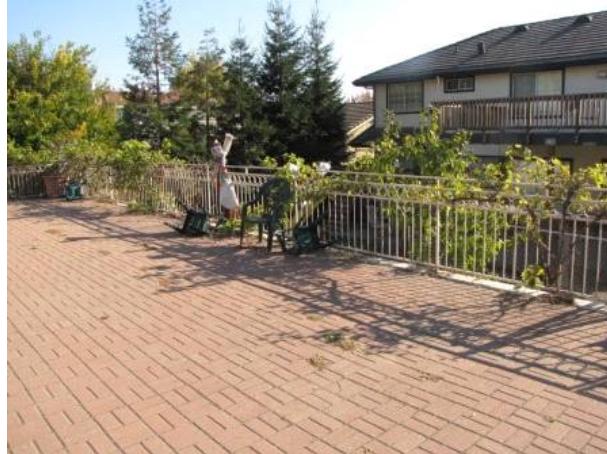
Levee Mile Report Line	20
Start Levee Mile	0.83
End Levee Mile	0.84
Location	Land Side
Category	Earthen Levee
Item	Encroachments
View of a fence on top of a large retaining wall in the landward slope looking upstream. Landscaping is growing along the fence.	
pkazi_f_20131001_183.jpg

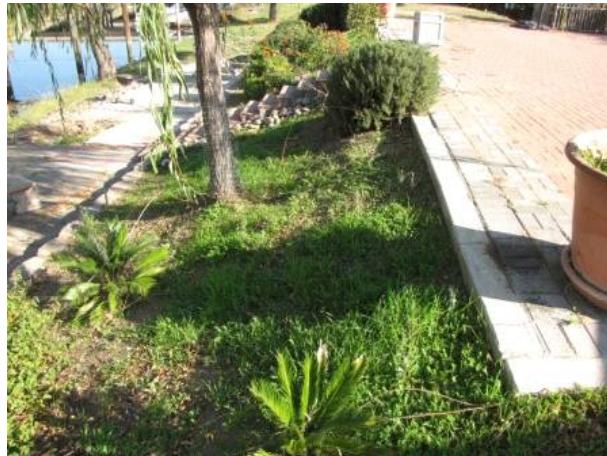
Levee Mile Report Line	21
Start Levee Mile	0.83
End Levee Mile	0.84
Location	Water Side
Category	Earthen Levee
Item	Vegetation
View of landscaping and irrigation on the waterward slope looking upstream.	
pkazi_f_20131001_185.jpg

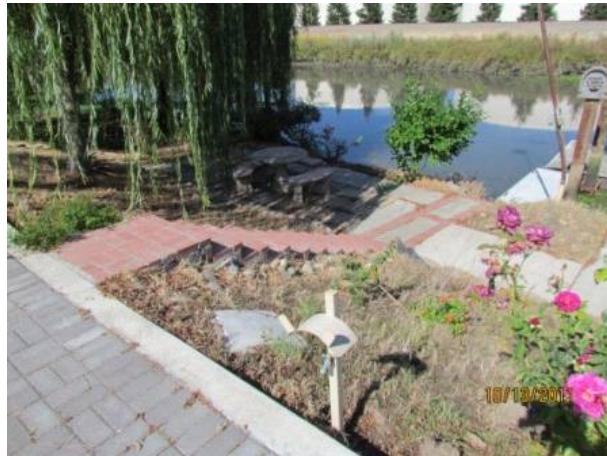
Levee Mile Report Line	21
Start Levee Mile	0.83
End Levee Mile	0.84
Location	Water Side
Category	Earthen Levee
Item	Vegetation
View of the landscaping on the waterside of the levee looking downstream. This picture was taken during fall 2011 inspection.	
pkazi_f_20131001_186.jpg

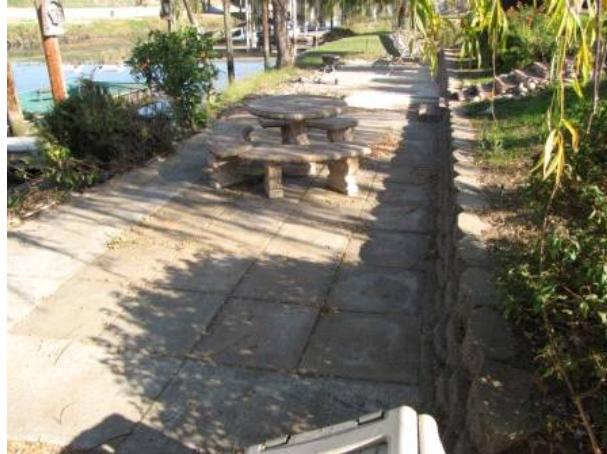
Levee Mile Report Line	22
Start Levee Mile	0.83
End Levee Mile	0.84
Location	Water Side
Category	Earthen Levee
Item	Encroachments
View of a retaining wall and patio with furniture in the waterward toe and berm looking upstream.	
pkazi_f_20131001_187.jpg

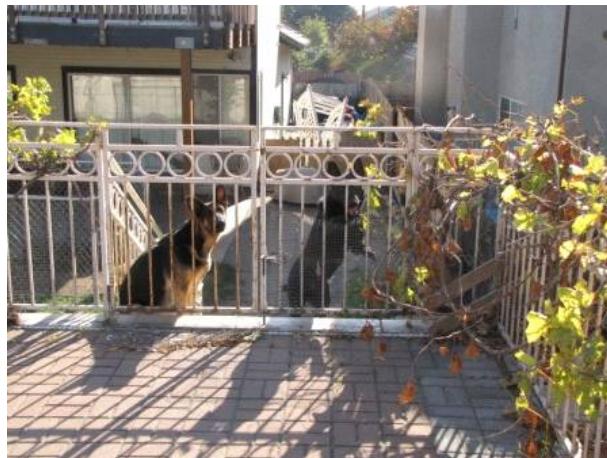
Levee Mile Report Line	23
Start Levee Mile	0.83
End Levee Mile	0.83
Location	Land Side
Category	Earthen Levee
Item	Encroachments
View of steps on the landward slope and dogs preventing a closer inspection.	
pkazi_f_20131001_184.jpg

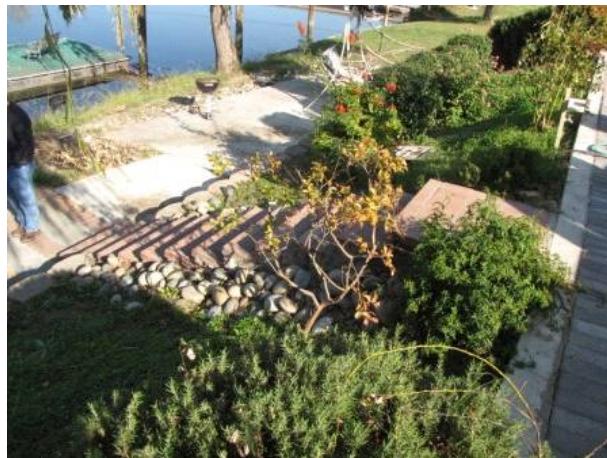
Levee Mile Report Line	24
Start Levee Mile	0.84
End Levee Mile	0.84
Location	Water Side
Category	Earthen Levee
Item	Encroachments
View of steps on the waterward slope of the levee looking upstream.	
pkazi_f_20131001_188.jpg

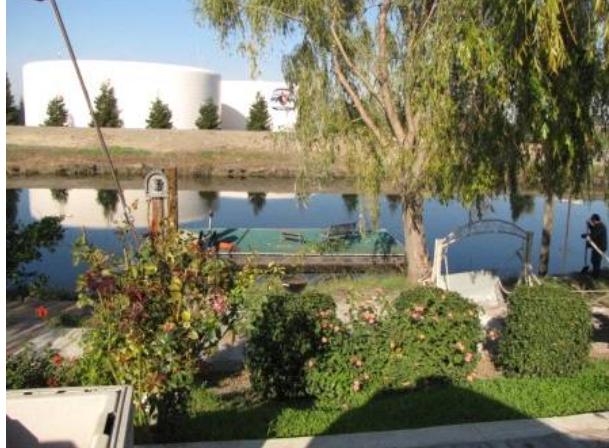
pkazi_f_20131001_189.jpg

Levee Mile Report Line	25
Start Levee Mile	0.84
End Levee Mile	0.84
Location	Water Side
Category	Earthen Levee
Item	Encroachments
View of a dock on the waterward side of the berm.

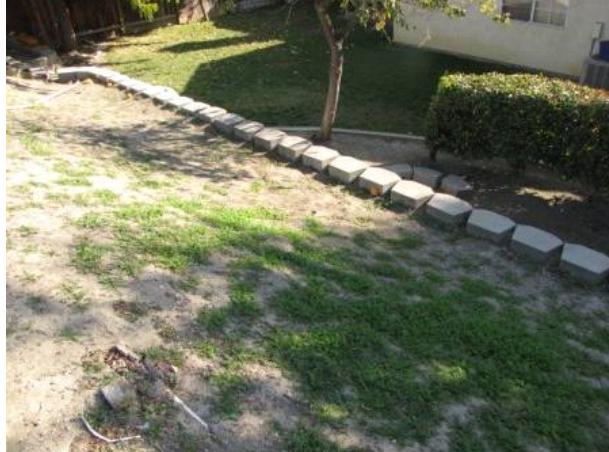
pkazi_f_20131001_190.jpg

Levee Mile Report Line	26
Start Levee Mile	0.84
End Levee Mile	0.85
Location	Land Side
Category	Earthen Levee
Item	Encroachments
View of a retaining wall in the landward slope.

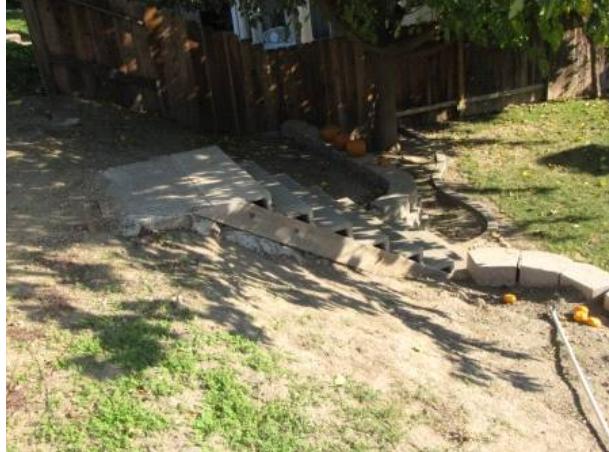
pkazi_f_20131001_191.jpg

Levee Mile Report Line	27
Start Levee Mile	0.85
End Levee Mile	0.85
Location	Land Side
Category	Earthen Levee
Item	Encroachments
View of steps on the landward slope looking upstream.

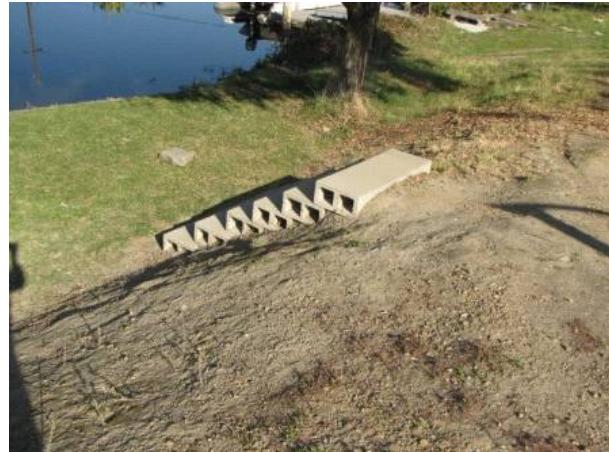
pkazi\_f\_20131001\_192.jpg

View of steps on the waterward slope looking upstream.

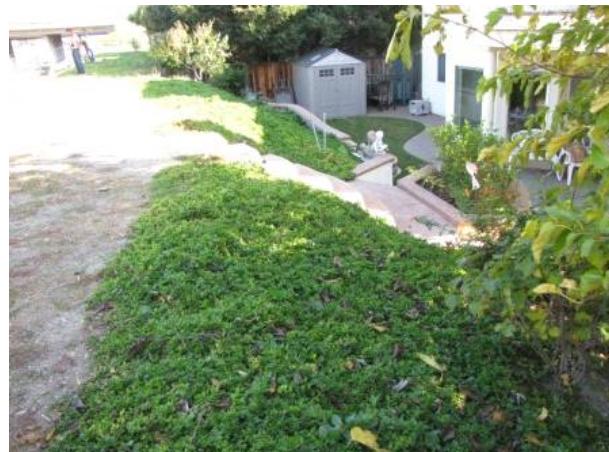
pkazi\_f\_20131001\_193.jpg

Levee Mile Report Line	29
Start Levee Mile	0.85
End Levee Mile	0.87
Location	Land Side
Category	Earthen Levee
Item	Vegetation

View of landscaping and irrigation on the landward slope looking upstream.

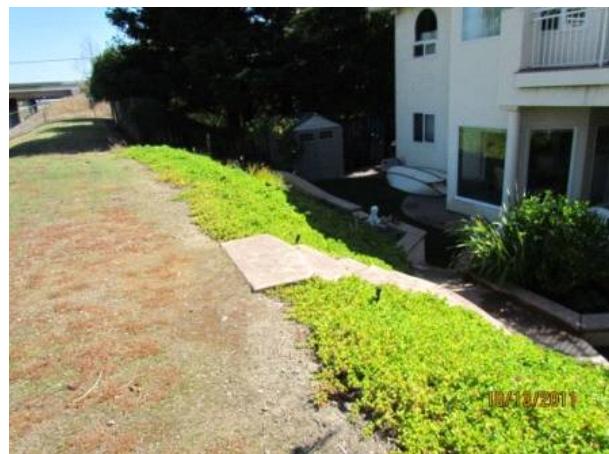
pkazi\_f\_20131001\_194.jpg

Levee Mile Report Line	29
Start Levee Mile	0.85
End Levee Mile	0.87
Location	Land Side
Category	Earthen Levee
Item	Vegetation

View of landscaping on the landside of the levee looking upstream. This picture was taken during fall 2011 inspection.

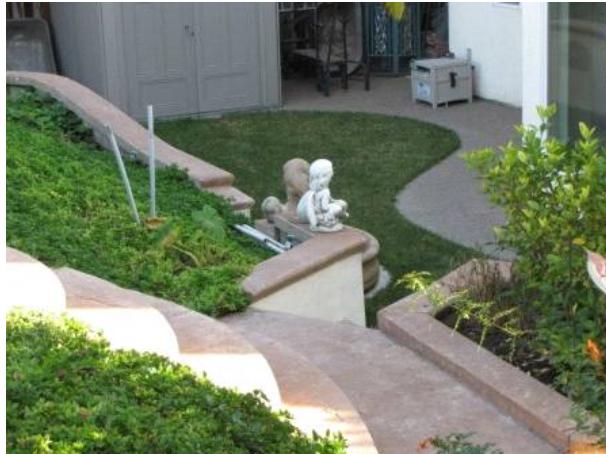
Levee Mile Report Line	30
Start Levee Mile	0.85
End Levee Mile	0.87
Location	Land Side
Category	Earthen Levee
Item	Encroachments
View of a retaining wall and patio in the landward slope.	
<i>pkazi_f_20131001_195.jpg</i>

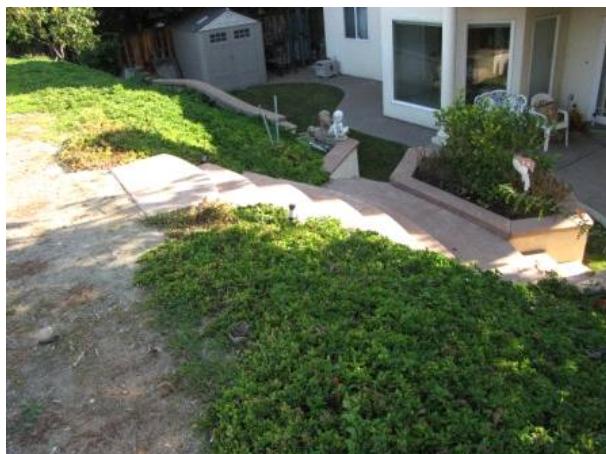
Levee Mile Report Line	31
Start Levee Mile	0.86
End Levee Mile	0.86
Location	Land Side
Category	Earthen Levee
Item	Encroachments
View of steps on the landward slope looking upstream.	
<i>pkazi_f_20131001_196.jpg</i>

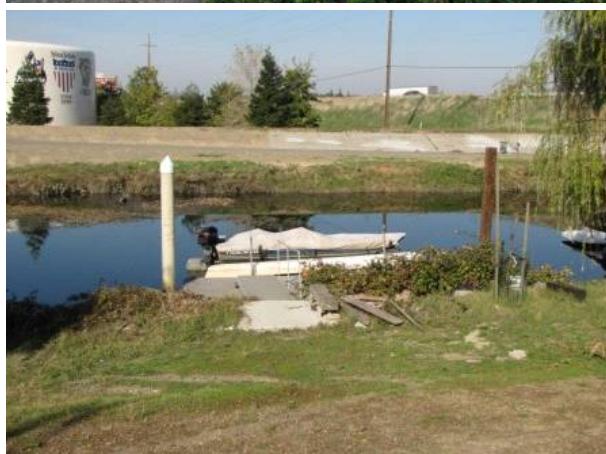
Levee Mile Report Line	32
Start Levee Mile	0.86
End Levee Mile	0.86
Location	Water Side
Category	Earthen Levee
Item	Encroachments
View of a dock and concrete pad on the waterward side of the berm.	
<i>pkazi_f_20131001_197.jpg</i>

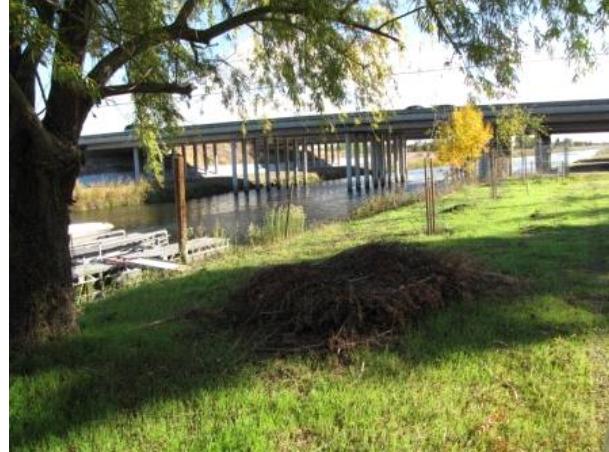
Levee Mile Report Line	33
Start Levee Mile	0.87
End Levee Mile	0.87
Location	Water Side
Category	Earthen Levee
Item	Encroachments
View of a prunings pile on the waterward berm looking upstream.	
pkazi_f_20131001_087.jpg

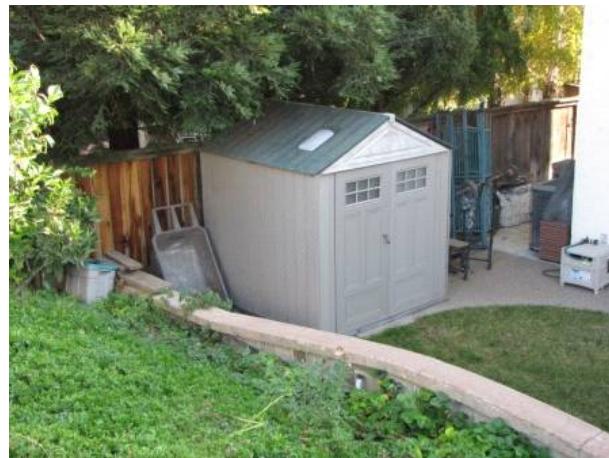
Levee Mile Report Line	34
Start Levee Mile	0.87
End Levee Mile	0.87
Location	Land Side
Category	Earthen Levee
Item	Encroachments
View of a shed located at the landward toe looking upstream.	
pkazi_f_20131001_198.jpg

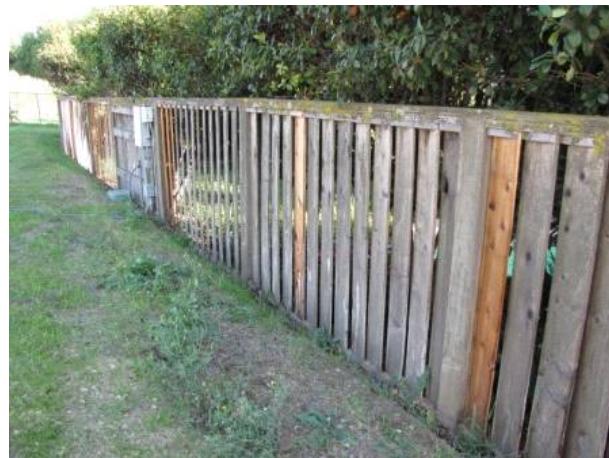
Levee Mile Report Line	35
Start Levee Mile	0.87
End Levee Mile	0.88
Location	Land Side
Category	Earthen Levee
Item	Encroachments
View of a fence at the landward shoulder blocking visibility and access looking upstream. Some encroachments can be seen through the fence but not with any detail. Also visible is an electrical panel and hose bib.	
pkazi_f_20131001_199.jpg

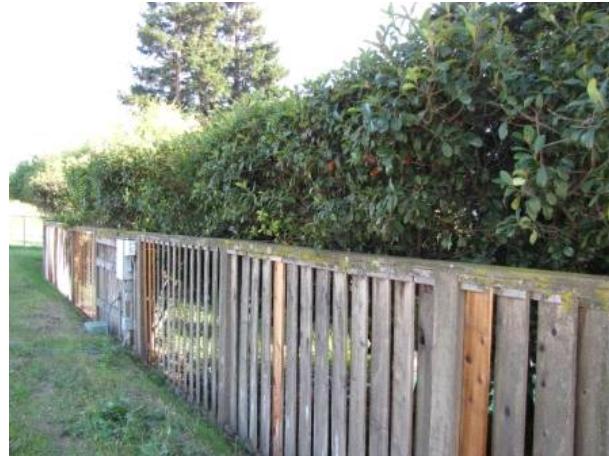
Levee Mile Report Line	36
Start Levee Mile	0.87
End Levee Mile	0.88
Location	Land Side
Category	Earthen Levee
Item	Vegetation
View of bushes above the fence at the landward shoulder further obstructing visibility looking upstream.	
pkazi_f_20131001_200.jpg

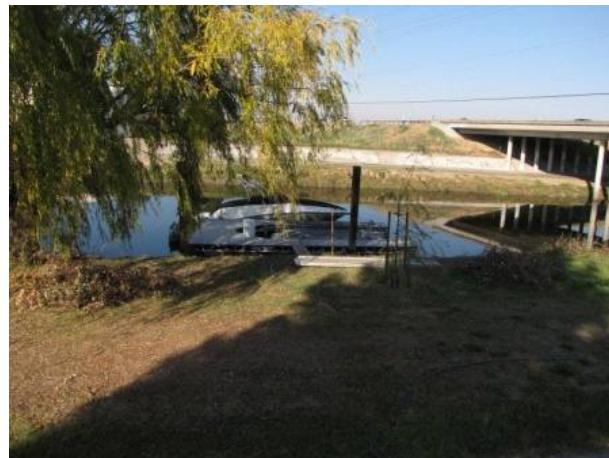
Levee Mile Report Line	37
Start Levee Mile	0.88
End Levee Mile	0.88
Location	Water Side
Category	Earthen Levee
Item	Encroachments
View of a dock on the waterward side of the berm.	
pkazi_f_20131001_201.jpg

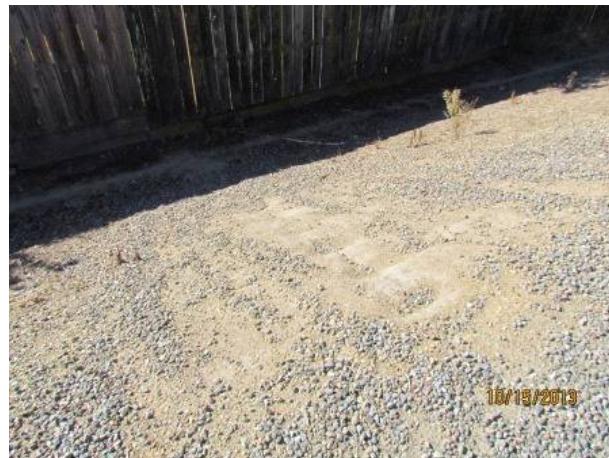
Levee Mile Report Line	42
Start Levee Mile	1.31
End Levee Mile	1.31
Location	Land Side
Category	Earthen Levee
Item	Encroachments
Steps were dug on the landside slope of the levee looking downstream.	
pkazi_f_20131026_000.JPG

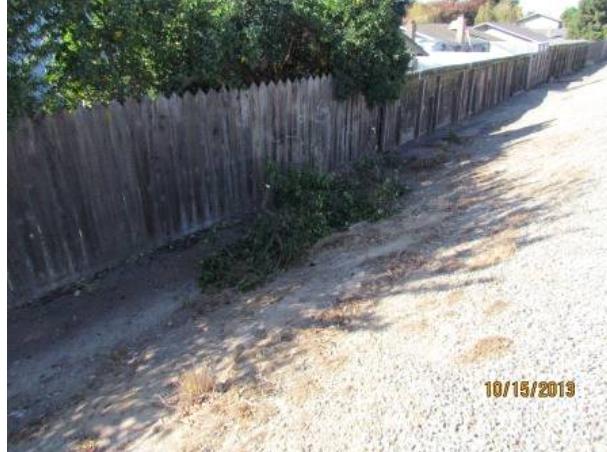
Levee Mile Report Line	43
Start Levee Mile	1.47
End Levee Mile	1.47
Location	Land Side
Category	Earthen Levee
Item	Encroachments
Prunings were found on the landside toe of the levee looking downstream.	
pkazi_f_20131025_999.JPG

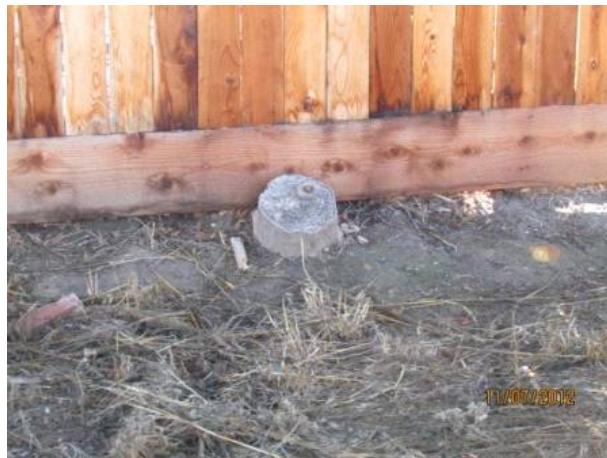
Levee Mile Report Line	47
Start Levee Mile	1.73
End Levee Mile	1.73
Location	Land Side
Category	Earthen Levee
Item	Trim / Thin Trees
A tree stump was found on the landside toe of the levee. The picture was taken from the crown looking towards the toe.	
pkazi_f_20131001_095.jpg

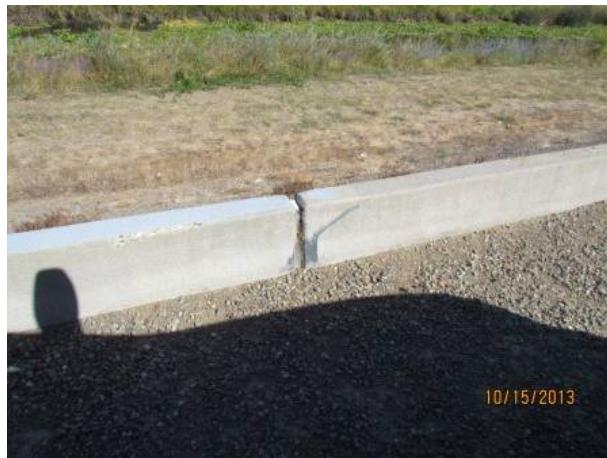
Levee Mile Report Line	48
Start Levee Mile	1.81
End Levee Mile	1.81
Location	Water Side
Category	Concrete Floodwalls
Item	Monolith Joints
The monolith joint material is deteriorating at this location of the flood wall. The picture was taken from the crown looking upstream.	
pkazi_f_20131026_001.JPG

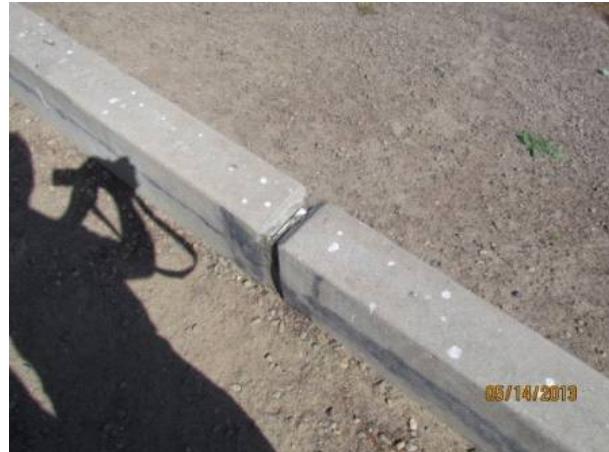
Levee Mile Report Line	49
Start Levee Mile	1.83
End Levee Mile	1.83
Location	Land Side
Category	Concrete Floodwalls
Item	Monolith Joints
The monolith joint material is deteriorating at this location of the flood wall. The picture was taken from the crown looking downstream.	
pkazi_f_20131001_088.JPG

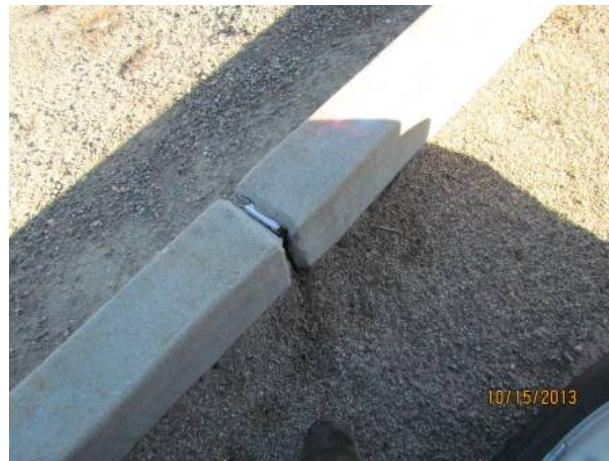
Levee Mile Report Line	50
Start Levee Mile	1.85
End Levee Mile	1.85
Location	Water Side
Category	Concrete Floodwalls
Item	Monolith Joints
The monolith joint material is deteriorating at this location of the flood wall. The picture was taken from the crown looking upstream.	
pkazi_f_20131025_998.JPG

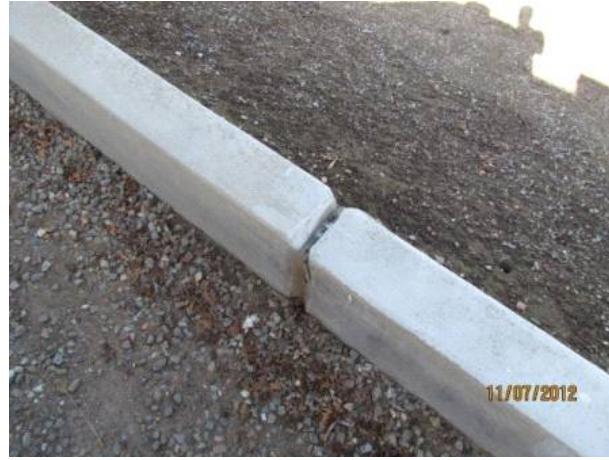
Levee Mile Report Line	51
Start Levee Mile	1.97
End Levee Mile	1.97
Location	Water Side
Category	Concrete Floodwalls
Item	Monolith Joints
The monolith joint material is deteriorating at this location. The picture was taken from crown looking downstream.	
pkazi_f_20131001_089.jpg

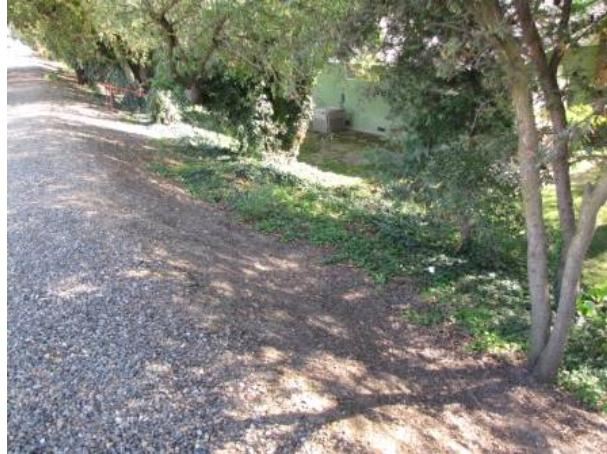
Levee Mile Report Line	52
Start Levee Mile	2.04
End Levee Mile	2.07
Location	Land Side
Category	Earthen Levee
Item	Vegetation
View of landscaping along the landward slope looking upstream. County crews have greatly reduced the amount of material and increased visibility and access.	
pkazi_f_20131001_149.jpg

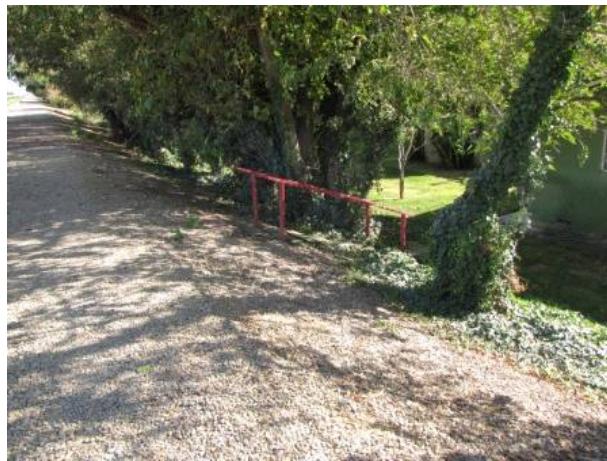
Levee Mile Report Line	53
Start Levee Mile	2.06
End Levee Mile	2.06
Location	Land Side
Category	Earthen Levee
Item	Encroachments
View of steps dug into the landward slope looking upstream.	
pkazi_f_20131001_150.jpg

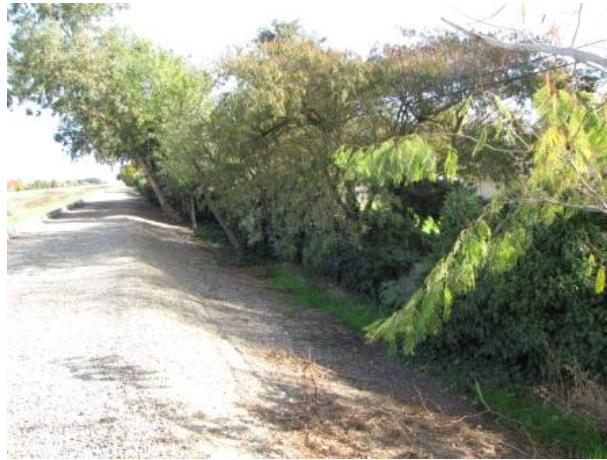
Levee Mile Report Line	56
Start Levee Mile	2.11
End Levee Mile	2.14
Location	Land Side
Category	Earthen Levee
Item	Encroachments
View of a fence with landscaping growing on it at the landward toe looking upstream.	
pkazi_f_20131001_151.jpg

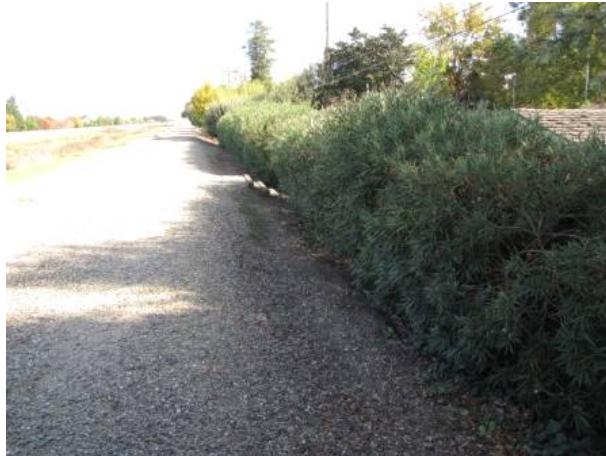
Levee Mile Report Line	57
Start Levee Mile	2.14
End Levee Mile	2.16
Location	Land Side
Category	Earthen Levee
Item	Vegetation
View of landscaping along the landward slope looking upstream.	
<i>pkazi_f_20131001_152.jpg</i>

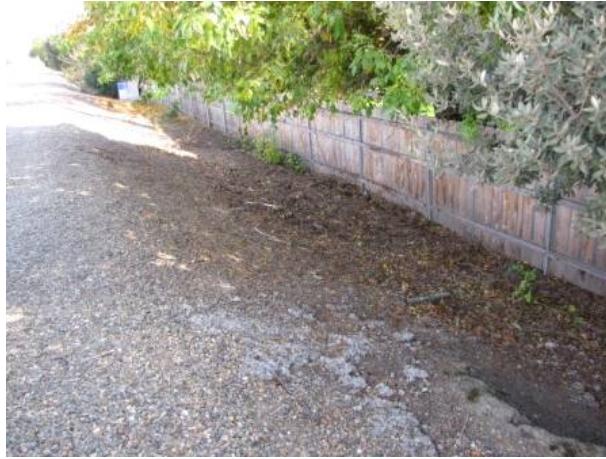
Levee Mile Report Line	58
Start Levee Mile	2.17
End Levee Mile	2.19
Location	Land Side
Category	Earthen Levee
Item	Encroachments
View of a fence along the landward toe looking upstream.	
<i>pkazi_f_20131001_153.jpg</i>

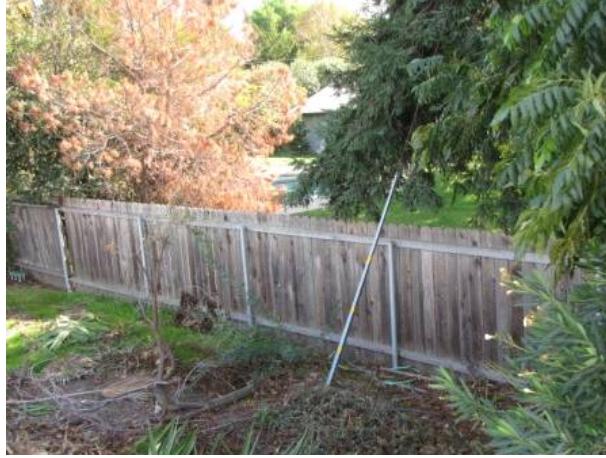
Levee Mile Report Line	59
Start Levee Mile	2.19
End Levee Mile	2.25
Location	Land Side
Category	Earthen Levee
Item	Encroachments
View of a fence along the landward toe looking upstream.	
<i>pkazi_f_20131001_154.jpg</i>

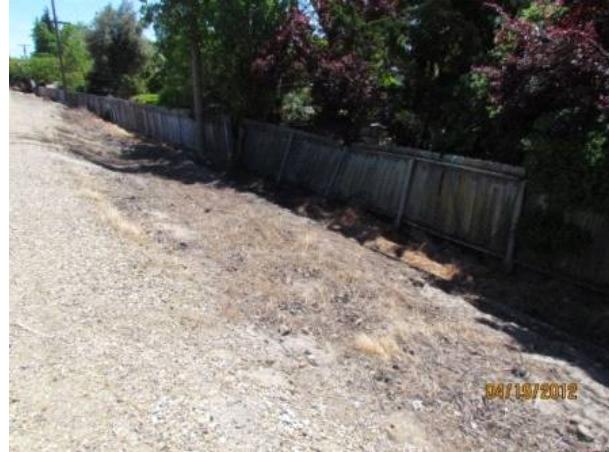
Levee Mile Report Line	59
Start Levee Mile	2.19
End Levee Mile	2.25
Location	Land Side
Category	Earthen Levee
Item	Encroachments
Fence was located on the landside toe of the levee looking upstream. This picture was taken during spring 2012 inspection.	pkazi_f_20131001_155.jpg

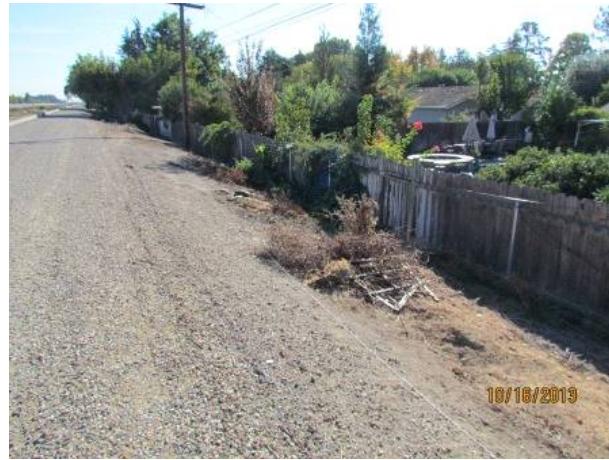
Levee Mile Report Line	61
Start Levee Mile	2.21
End Levee Mile	2.21
Location	Land Side
Category	Earthen Levee
Item	Encroachments
Prunings were found on the landside toe of the levee looking upstream.	pkazi_f_20131028_006.JPG

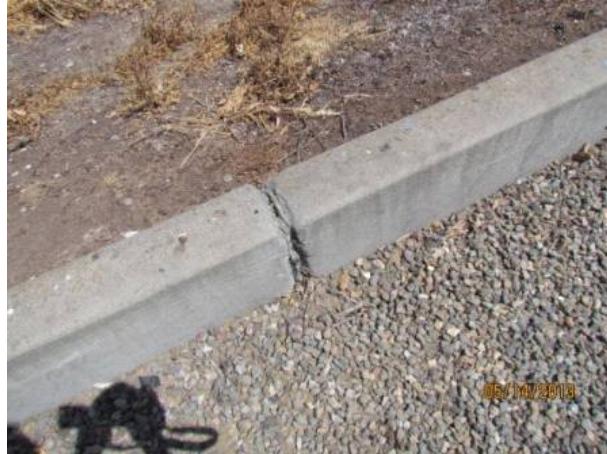
Levee Mile Report Line	62
Start Levee Mile	2.22
End Levee Mile	2.22
Location	Water Side
Category	Concrete Floodwalls
Item	Monolith Joints
The monolith joint material is deteriorating at this location of the flood wall. The picture was taken from the crown looking upstream.	
pkazi_f_20131001_106.JPG

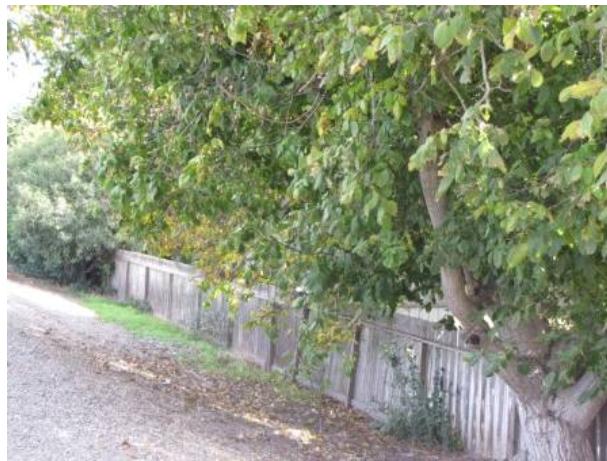
Levee Mile Report Line	63
Start Levee Mile	2.25
End Levee Mile	2.30
Location	Land Side
Category	Earthen Levee
Item	Encroachments
View of a wood fence at the landward toe.	
pkazi_f_20131001_156.jpg

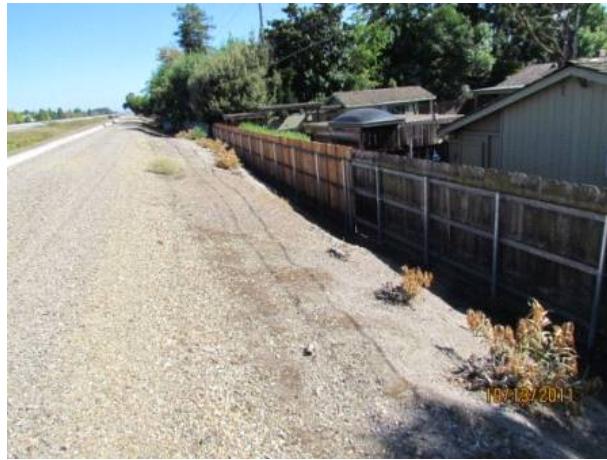
Levee Mile Report Line	63
Start Levee Mile	2.25
End Levee Mile	2.30
Location	Land Side
Category	Earthen Levee
Item	Encroachments
View of the fence on the landside toe of the levee looking upstream. This picture was taken during fall 2011 inspection.	
pkazi_f_20131001_157.jpg

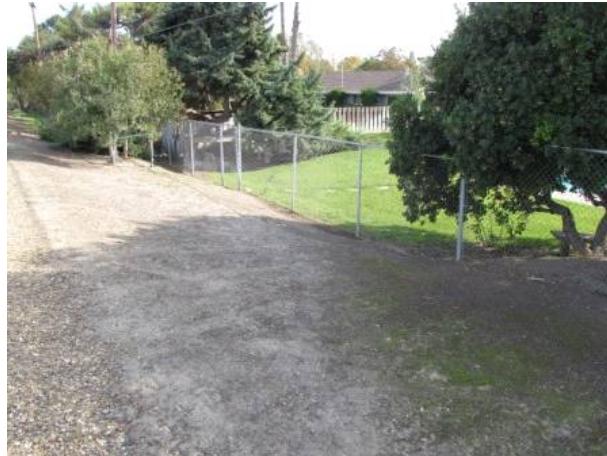
Levee Mile Report Line	64
Start Levee Mile	2.30
End Levee Mile	2.38
Location	Land Side
Category	Earthen Levee
Item	Encroachments
View of a fence on the landward slope looking upstream.	
pkazi_f_20131001_158.jpg

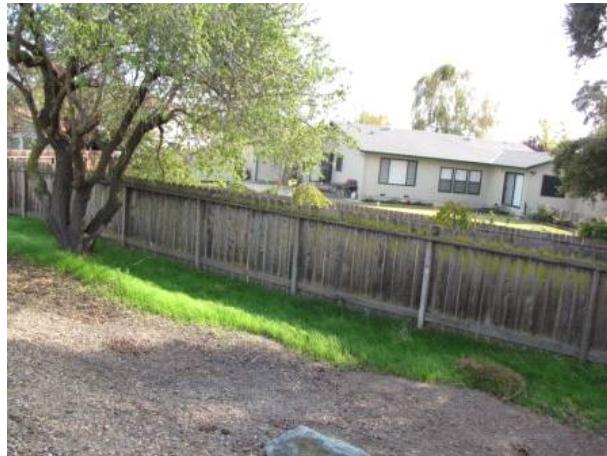
Levee Mile Report Line	67
Start Levee Mile	2.38
End Levee Mile	2.40
Location	Land Side
Category	Earthen Levee
Item	Encroachments
View of a fence at the landward toe.	
pkazi_f_20131001_159.jpg

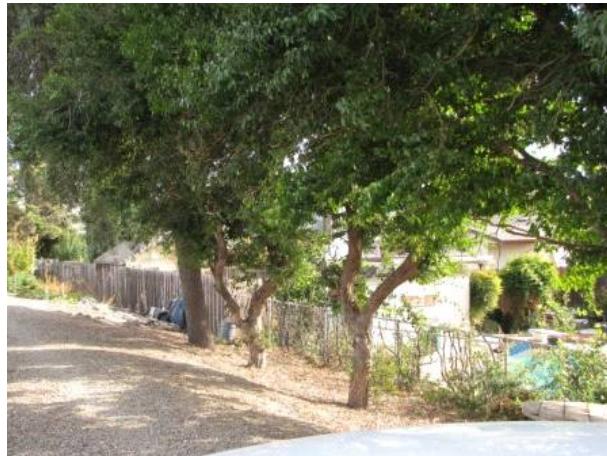
Levee Mile Report Line	68
Start Levee Mile	2.40
End Levee Mile	2.43
Location	Land Side
Category	Earthen Levee
Item	Encroachments
View of a fence at the landward toe.	
pkazi_f_20131001_160.jpg

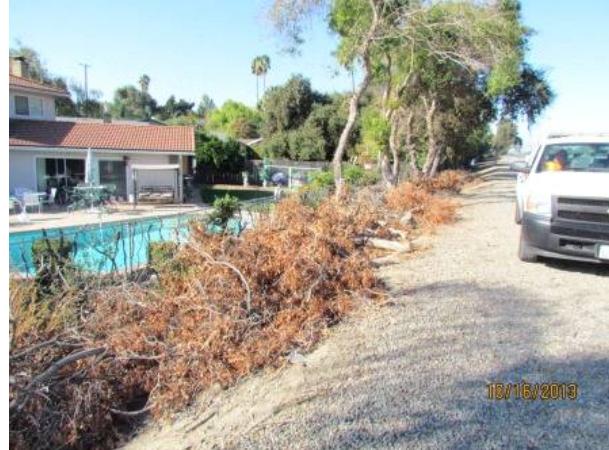
Levee Mile Report Line	69
Start Levee Mile	2.43
End Levee Mile	2.43
Location	Land Side
Category	Earthen Levee
Item	Encroachments
Prunings were found on the landside toe of the levee looking downstream.	
pkazi_f_20131028_007.JPG
